Downtown Elizabeth City Sign Assessment Technical Summary

Elizabeth City, North Carolina

February 28, 2019

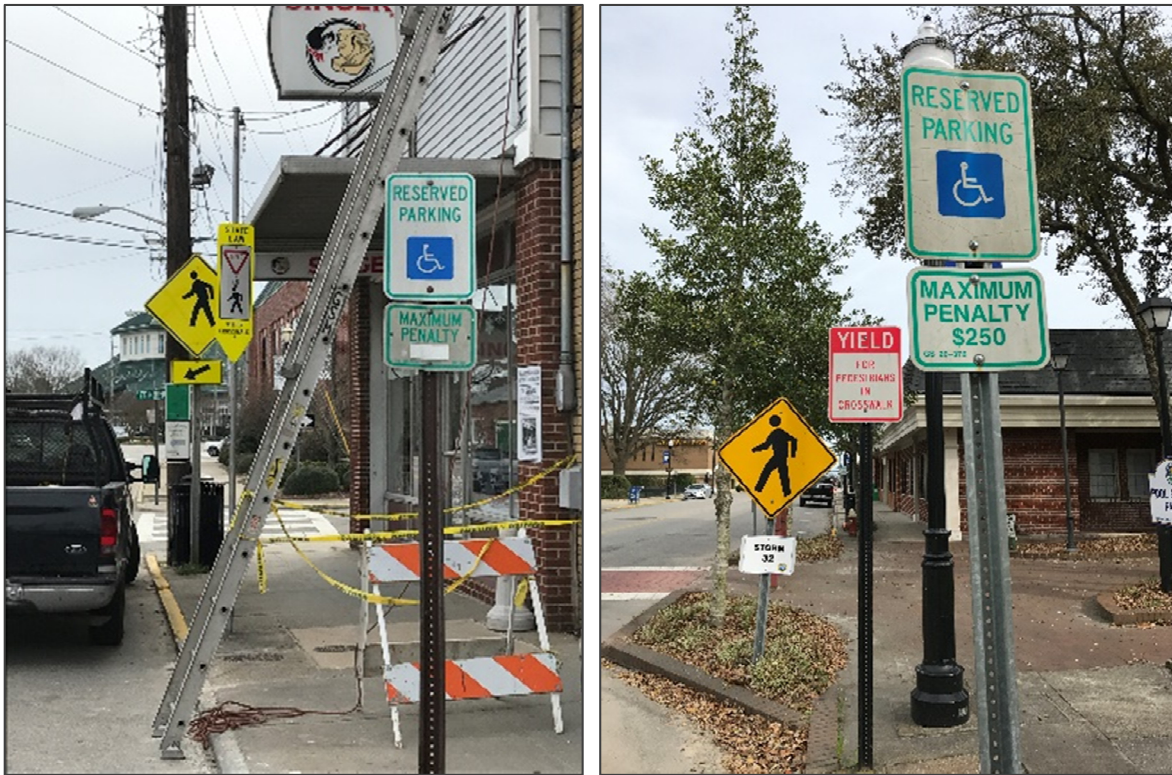
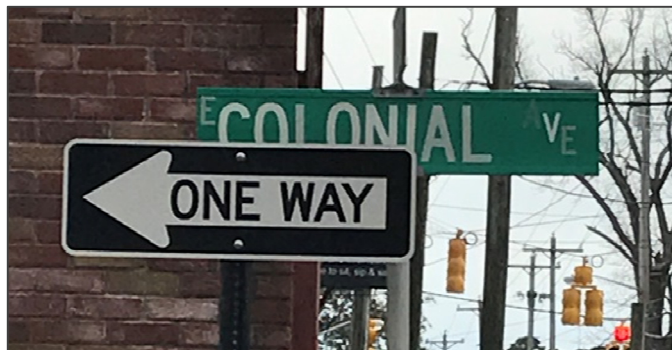
Exhibit 1: Photographs of Existing Sign Clutter

There were two (2) distinct observations in the field that are noted in the assessments. First, several post-mounted sign panels are not installed at a minimum height of 7 feet to prevent the view of the sign being obstructed by parked vehicles or pedestrian traffic and/or impacting pedestrian mobility along sidewalks. Secondly, there are many locations of cluttered sign panels that provide an over-abundance of information to roadway users (see **Exhibit 1**). At these locations, sign messages are difficult to interpret, and in some cases, conflict with one another.

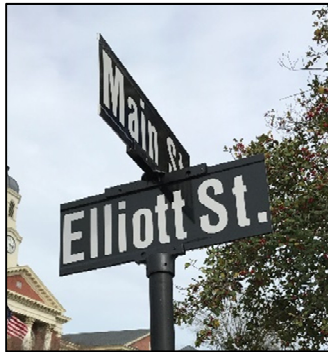
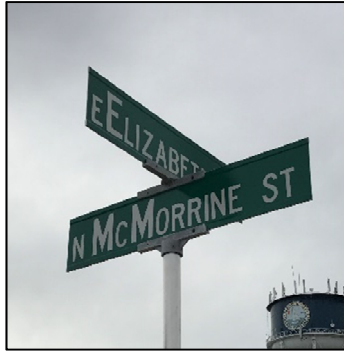
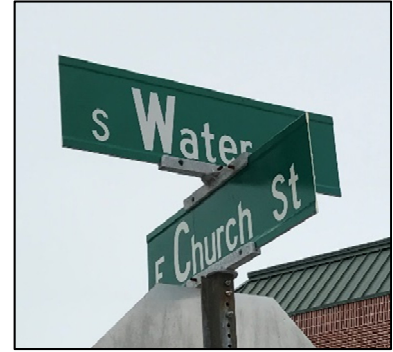
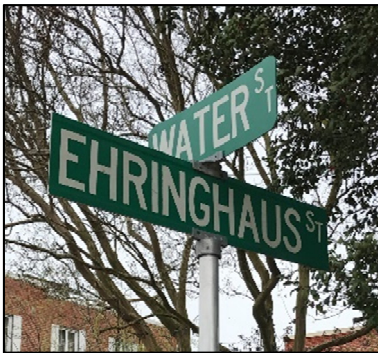
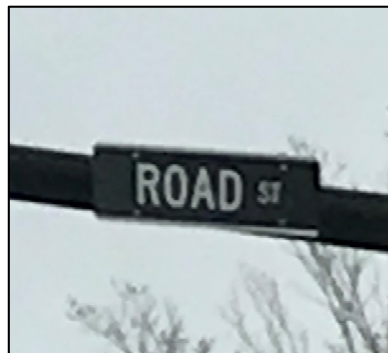
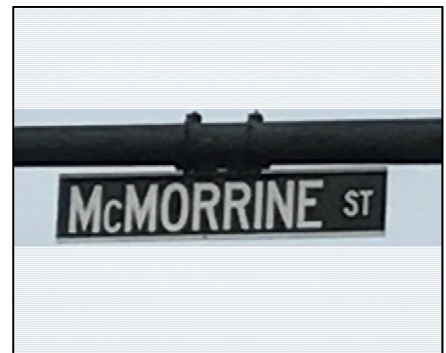
Exhibit 2: Photographs of Existing Street Name Signs

Existing street name sign panels are inconsistent throughout the study area, as shown in **Exhibit 2**. Background colors differ between green and black, and lettering within the legends differ in terms of text style, text height, capitalization, and placement. As a result, most street name sign panels are not in compliance with current MUTCD and North Carolina MUTCD Supplement guidelines. Per the MUTCD, all street name sign panels shall comply with Chapter 2D (Guide Signs – Conventional Roads). Although inconsistent and non-compliant with current standards, all existing street name sign panels are in good physical condition.

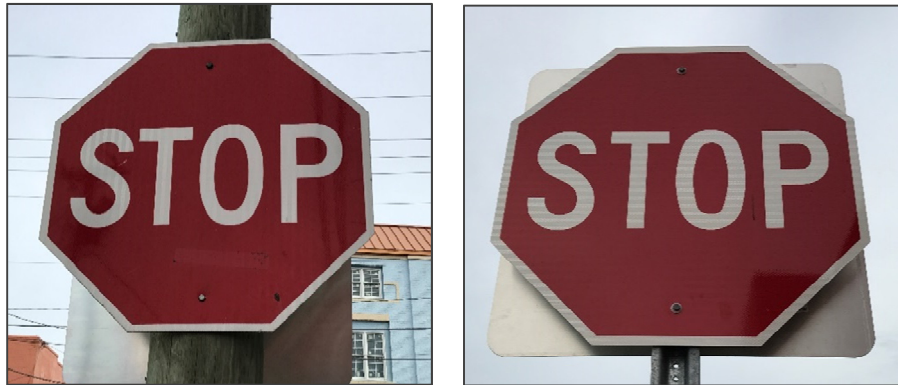
Exhibit 3: Photographs of Existing R1-1 Sign Panels

Existing R1-1 panels are consistent throughout the study area, and compliant with current MUTCD and North Carolina MUTCD Supplement guidelines. R1-1 sign criteria is included in Chapter 2B (Section 2B.05) of the MUTCD. All existing inventoried R1-1 sign panels are in good physical condition.

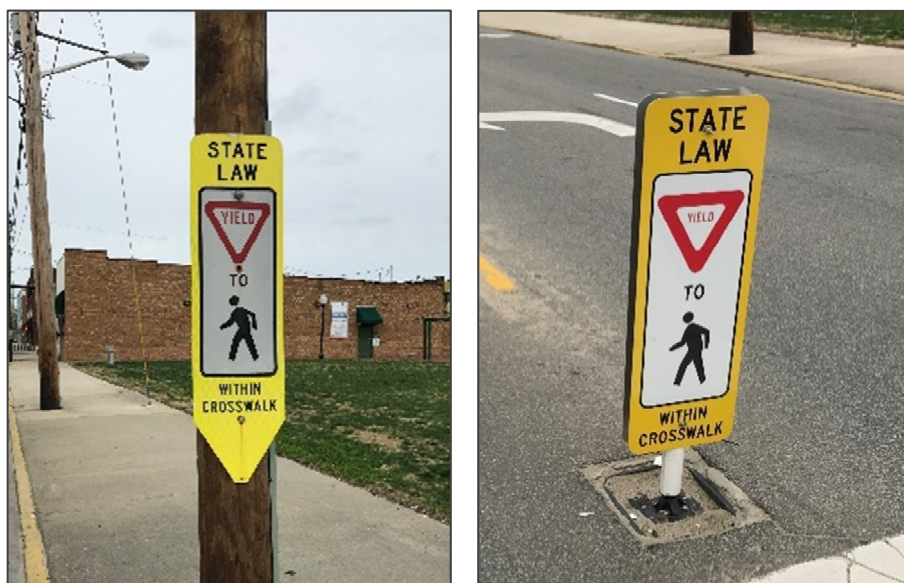
Exhibit 4: Photographs of Existing R1-6 Sign Panels

Existing R1-6 sign panels are both post mounted and installed within the roadway throughout the study area, as shown in **Exhibit 4**. As a result, those mounted on poles are not compliant with MUTCD and North Carolina MUTCD Supplement guidelines. R1-6 sign criteria is included in Chapter 2B (Section 2B.12) of the MUTCD. All existing inventoried R1-6 sign panels are in good physical condition.

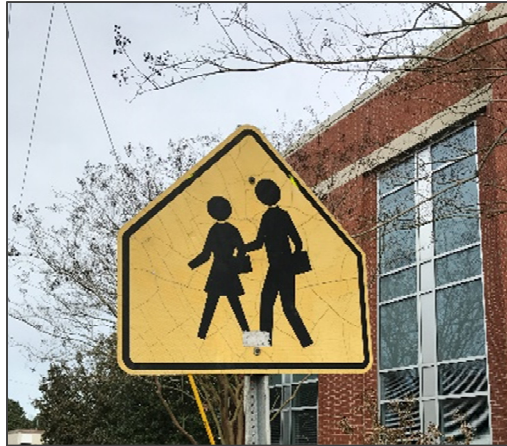
Exhibit 6: Photograph of Existing S1-1 Sign Panel

Only one existing S1-1 sign panel is located within the study area (**Exhibit 6**). The existing S1-1 panel is not compliant with MUTCD and North Carolina Supplement guidelines with regards to background color (i.e., should be fluorescent yellow-green). S1-1 sign criteria is included in Chapter 7B (Section 7B.08) of the MUTCD. The existing S1-1 sign is in poor condition, with significant cracking throughout the panel and legend.

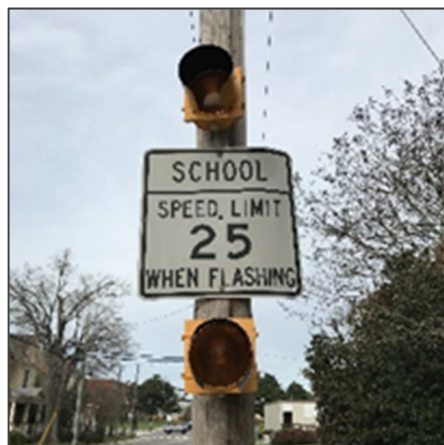
Exhibit 7: Photograph of Existing S5-1 Sign Panel

Only one existing S5-1 sign panel is located within the study area (**Exhibit 7**). The existing S5-1 panel is not compliant with MUTCD and North Carolina Supplement guidelines with respect to the number and configuration of sign panels needed at school speed limit flashing beacon locations. S5-1 sign criteria is included in Chapter 7B (Section 7B.15) of the MUTCD. The existing S5-1 sign text is still relatively legible however, the right-half of the physical panel has been damaged and is bent backwards.

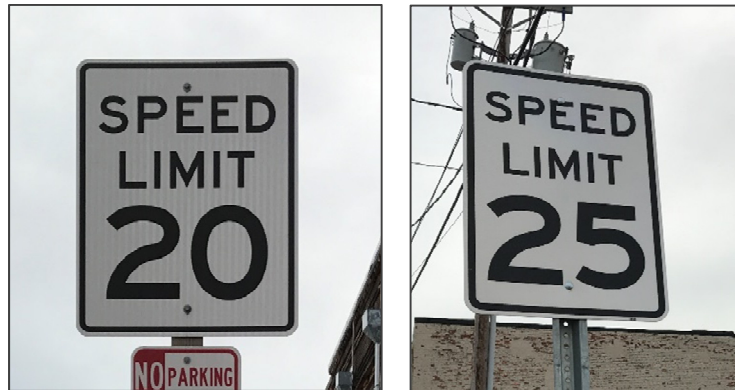
Exhibit 5: Photographs of Existing R2-1 Sign Panels

Existing R2-1 panels are consistent throughout the study area (**Exhibit 5**), and are compliant with the MUTCD and North Carolina Supplement guidelines. R2-1 sign criteria is included in Chapter 2B (Section 2B.13) of the MUTCD. All existing inventoried R2-1 sign panels are in good physical condition.

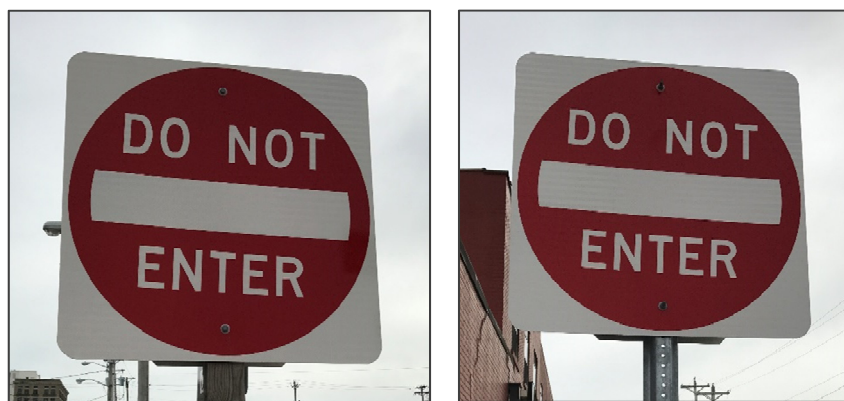
Exhibit 8: Photograph of Existing R5-1 Sign Panels

Existing R5-1 panels are consistent throughout the study area (**Exhibit 8**), and are compliant with MUTCD and North Carolina Supplement guidelines. R5-1 sign criteria is included in Chapter 2B (Section 2B.37) of the MUTCD. All existing inventoried R5-1 sign panels are in good physical condition.

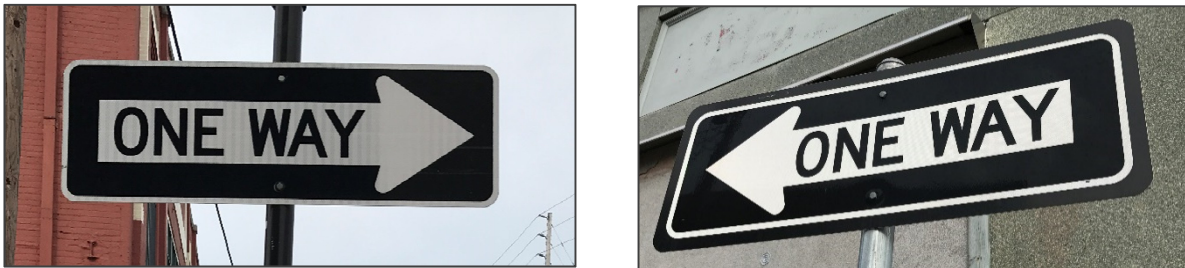
Exhibit 10: Photographs of Existing R6-1 Sign Panels

Existing R6-1 panels are consistent throughout the study area (**Exhibit 10**). Although border thicknesses and type vary among signs, the MUTCD indicates that border thickness is a “should” condition, and not a “shall” condition. Therefore, the current R6-1 panels are consistent with MUTCD and North Carolina Supplement guidelines. It is important to note that starting December 31, 2019, new R6-1 compliance guidelines will become effective (see Chapter 2B, Section 2B.40) of the MUTCD. All existing inventoried R6-1 sign panels are in good physical condition.

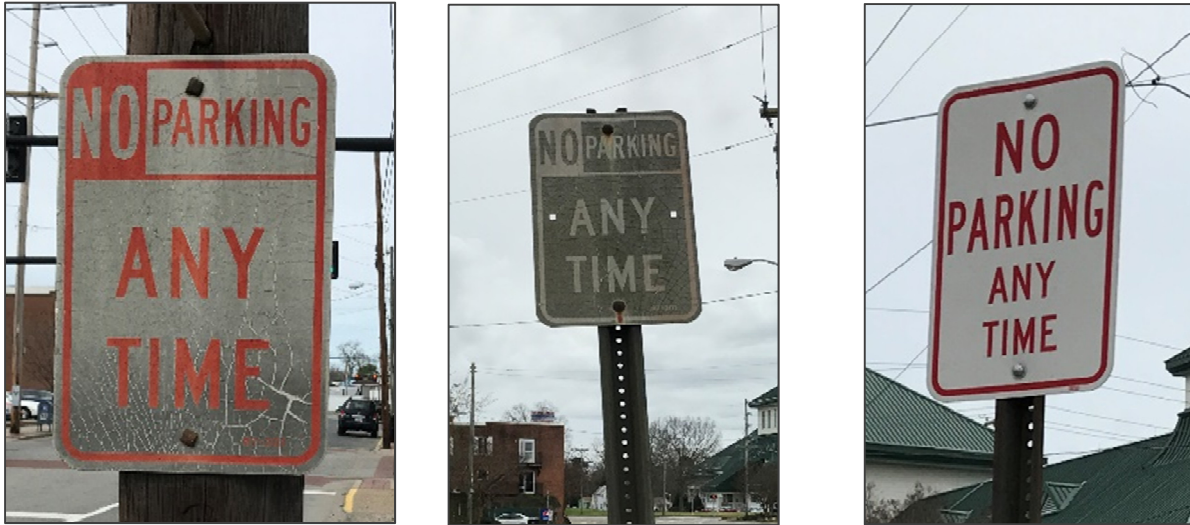
Exhibit 11: Photographs of Existing R7-1 Sign Panels

Existing R7-1 panels are not consistent throughout the study area, as shown in **Exhibit 11**. The existing R7-1 panels have varying background colors and have lettering within the legends that differ in terms of text style, text height, capitalization, and placement. As a result, most of the R7-1 panels are not in compliance with MUTCD and North Carolina Supplement guidelines. R7-1 sign criteria is included in Chapter 2B (Section 2B.46) of the MUTCD. Mostly all existing inventoried R7-1 sign panels are in poor physical condition with cracking and overall discoloration.

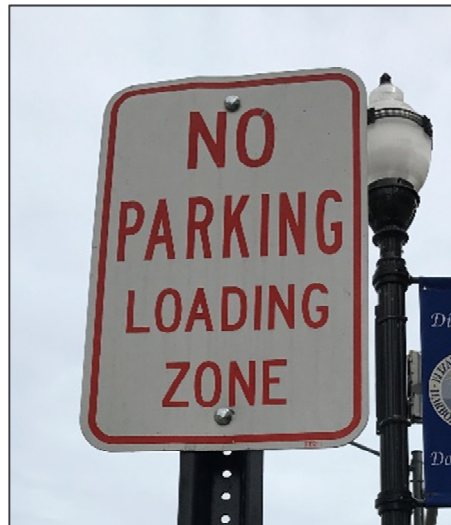
Exhibit 12: Photograph of Existing R7-6 Sign Panel

Only one existing R7-6 sign panel is located within the study area (**Exhibit 12**). The existing R7-6 panel is compliant with MUTCD and North Carolina Supplement guidelines. R7-6 sign criteria is included in Chapter 2B (Section 2B.46) of the MUTCD. The existing inventoried R7-6 sign panel is in good physical condition.

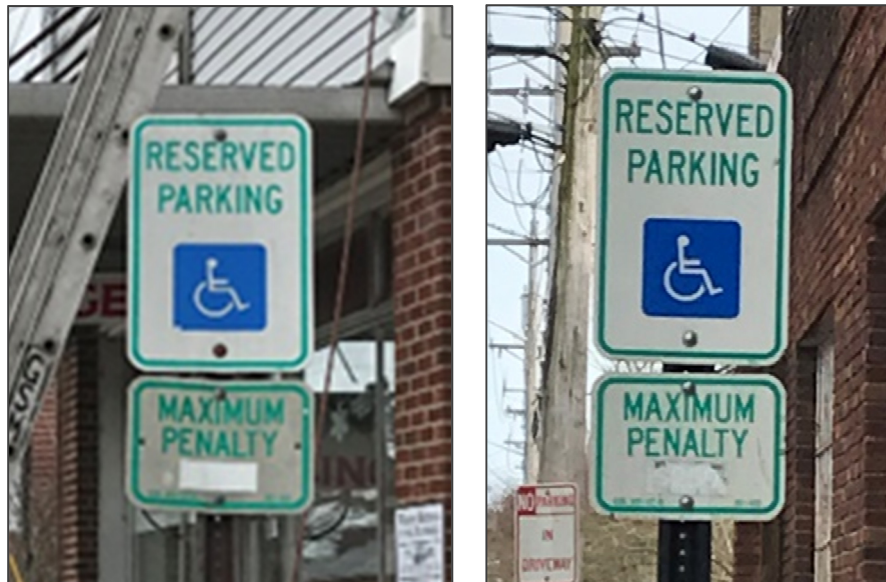
Exhibit 13: Photographs of Existing R7-8 Sign Panels

Existing R7-8 panels are consistent throughout the study area (**Exhibit 13**), and are compliant with MUTCD and North Carolina Supplement guidelines. R7-8 sign criteria is included in Chapter 2B (Section 2B.46) of the MUTCD. Several locations do not indicate the maximum penalty amount on the supplementary plaques that are currently present below the R7-8 panels. The existing supplementary plaques appear to have the previous maximum penalty amounts covered and not updated. With regards to physical condition, most of the existing inventoried R7-8 panels are in poor condition, with cracking and discoloration present.

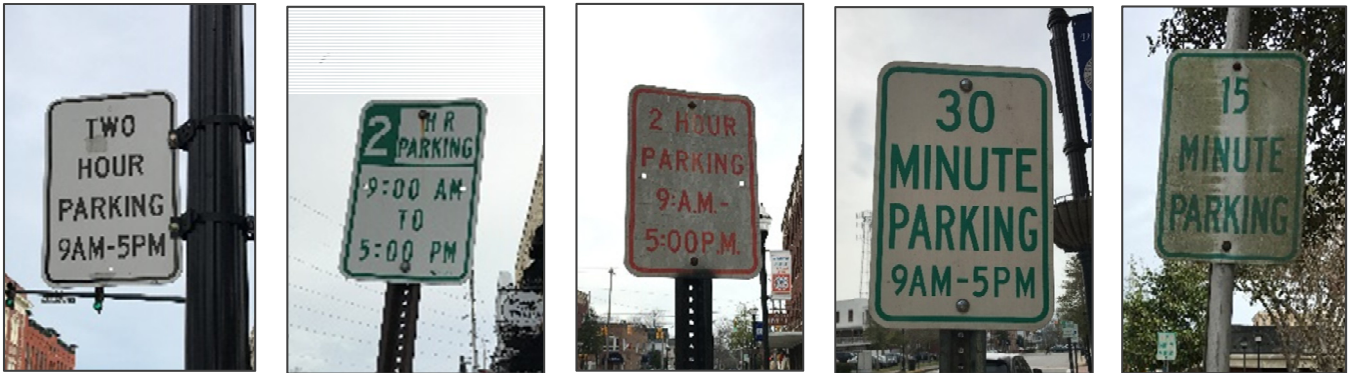
Exhibit 14: Photographs of Existing R7-108 Sign Panels

Existing R7-108 panels vary throughout the study area (**Exhibit 14**) reflecting 15-minute, 30-minute, and 2-hour parking restrictions. Lettering within the legends differ in terms of text style, text height, text color and placement, which makes most panels not compliant with MUTCD or North Carolina Supplement guidelines. R7-8 sign criteria is included in Chapter 2B (Section 2B.46) of the MUTCD. With regards to physical condition, most of the existing inventoried R7-108 panels are in poor condition, with cracking, discoloration, and holes present along the panel surfaces.

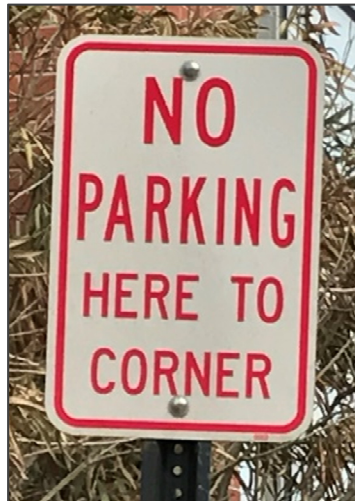
Exhibit 15: Photograph of Existing R8-1 Custom Sign Panel

Only one existing R8-1 Custom sign panel is located within the study area (**Exhibit 15**). The existing R8-1 Custom sign panel is compliant with MUTCD and North Carolina Supplement guidelines. R8-1 sign criteria is included in Chapter 2B (Section 2B.47) of the MUTCD. The existing inventoried R8-1 custom sign panel is in good physical condition.
